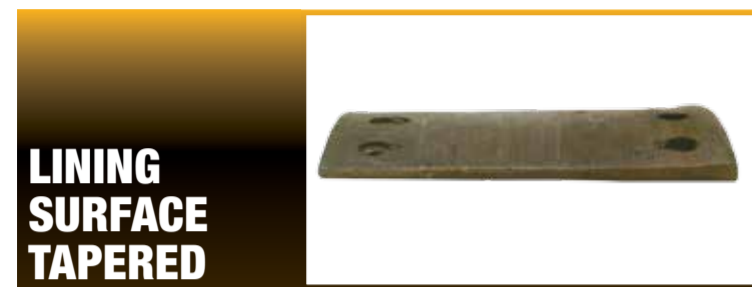
LINING SURFACE TAPERED

- Brake shoes misaligned with the brake drum
- Distorted brake shoe or brake drum turned on taper

- The linings may lock on to the drum when braking from high speeds
- Vehicle pull and excessive brake noise may occur

SOLUTION Replace or grind/machine drum. Replace brake shoe anchor pins or parts that locate brake shoes

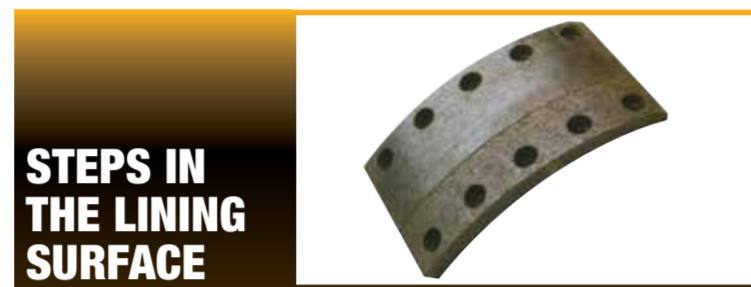
STEPS IN THE LINING SURFACE

- There may be a step in the brake drum surface
- General drum wear

- Rapid lining wear
- If the wear pattern differs across the axle, vehicle pull and excessive noise can result

SOLUTION Grind/Machine drum surface or renew (a drum grind may incur oversize lining fitment)

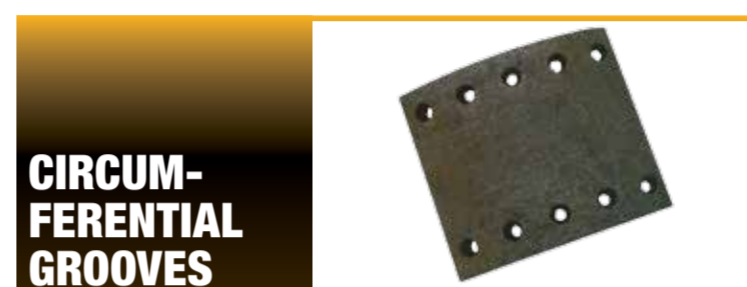
CIRCUMFERENTIAL GROOVES

- Poor drum condition
- Improper preparation with a wire brush, shoe grinder or similar

- Vehicle pull may occur if there is a different wear pattern on the opposite axle end
- Insufficient deceleration and excessive noise

SOLUTION Replace linings and grind or replace drum as appropriate

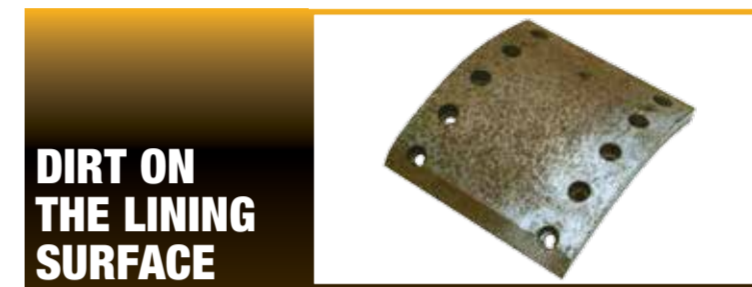
DIRT ON THE LINING SURFACE

- Dirt particles in the brake
- Poor brake maintenance (insufficient cleaning)

- High lining and drum wear
- Poor deceleration
- Vehicle pull and excessive brake noise may occur

SOLUTION If heavy contamination, replace linings and ensure contamination-free relining operation

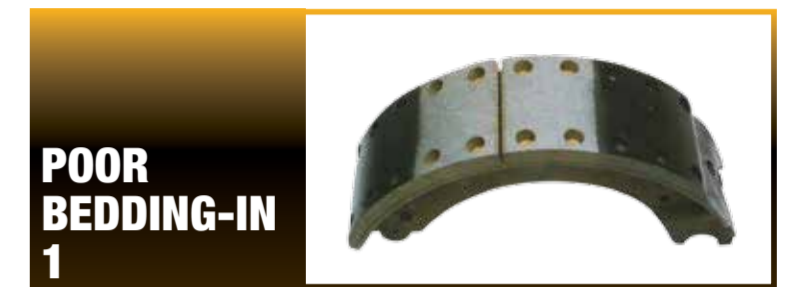
POOR BEDDING-IN 1

- Lining radius is larger than actual drum diameter
- Bedding-in period for the lining was too short

- Vehicle pull and excessive brake noise may occur
- Low deceleration

SOLUTION Replace linings and ensure the correct lining radius to drum diameter is selected, or extend bedding-in period

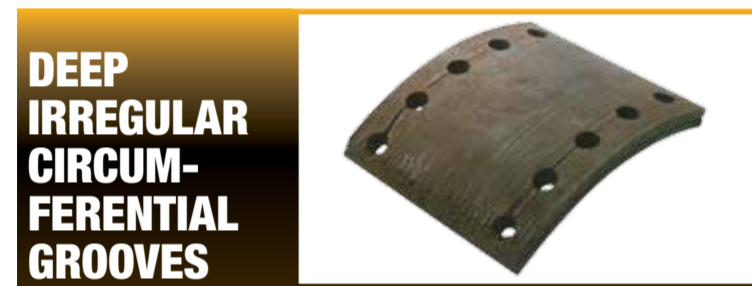
DEEP IRREGULAR CIRCUMFERENTIAL GROOVES

- Large particles loose in the brake
- Very poor drum condition and maintenance

- Very high lining and drum wear
- Squeal

SOLUTION Avoid contamination. Replace linings and grind or replace drum as appropriate.

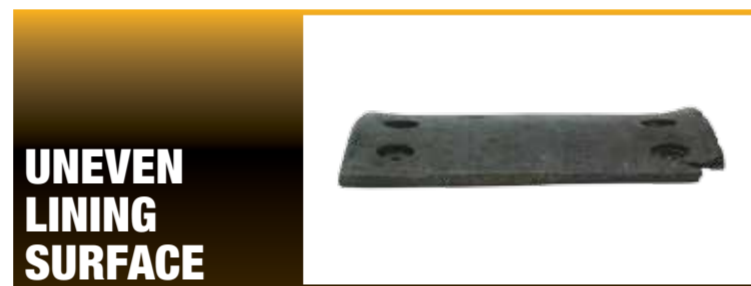
UNEVEN LINING SURFACE

- Wrongly adjusted or worn axle bearings

- Very high lining and drum wear
- Squeal

SOLUTION Replace linings, replace wheel bearing and replace or grind drum as appropriate

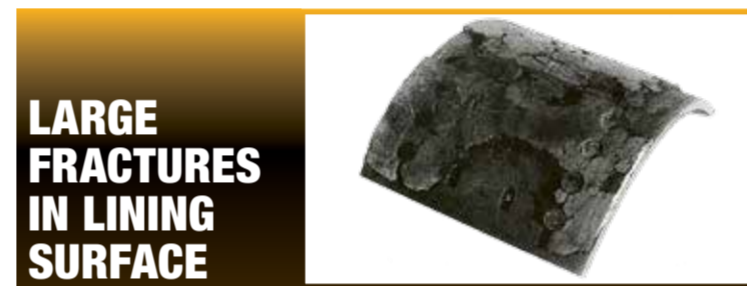
LARGE FRACTURES IN LINING SURFACE

- Faults in brake mechanism
- Sticking brake shoes (weak return springs)
- Excessive use of brakes at high speed
- Overloaded vehicle
- Too large air chambers

- High lining wear
- Vehicle pull and excessive brake noise
- Disintegration of lining
- Low deceleration

SOLUTION Replace linings, avoid overworking brakes and ensure brake components are correct and are in good condition

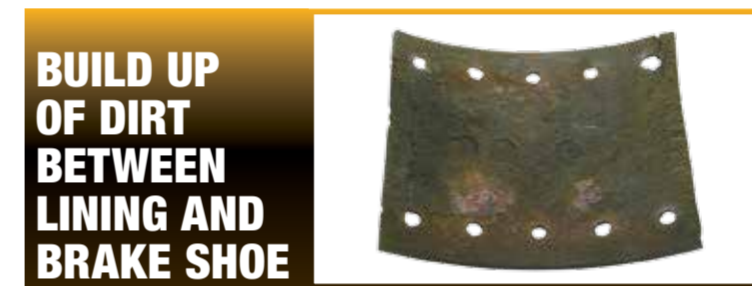
BUILD UP OF DIRT BETWEEN LINING AND BRAKE SHOE

- Shoe radius out of line
- Shoe platform not blast cleaned and painted properly
- Shoe platform not parallel
- Lining riveted incorrectly

- Cracks in the lining material or crack in drum surface
- Loose linings
- Squeal
- Improper cleaning causes rust scale to build up and lift the lining from the shoe

SOLUTION Replace linings and ensure shoe is clean and free from contamination before lining fitment

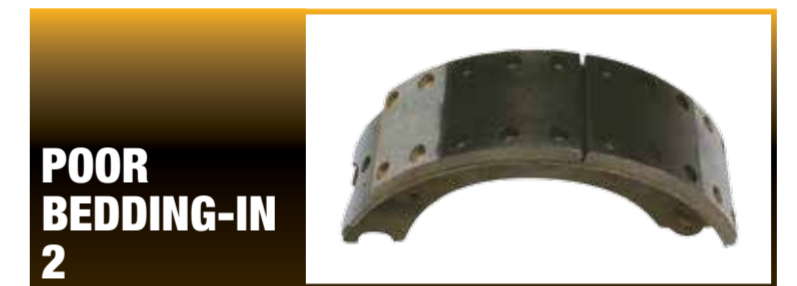
POOR BEDDING-IN 2

- Drum diameter is larger than lining radius
- Bedding-in period for the lining was too short
- Drum wear

- If the wear pattern differs across the axle, vehicle pull can result; also excessive brake noise
- Low deceleration

SOLUTION Replace linings and ensure the correct lining radius to drum diameter is selected, or extend bedding-in period

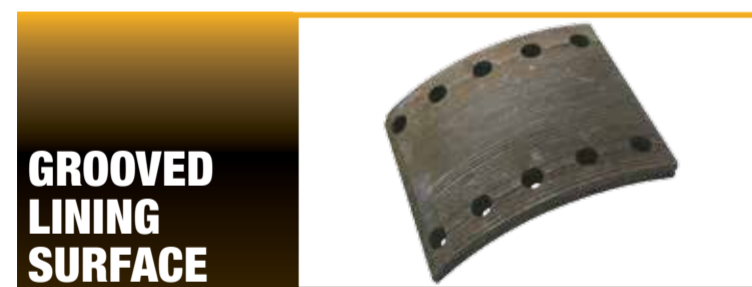
GROOVED LINING SURFACE

- Small loose particles in the brake
- Insufficient drum cleaning at replacement

- Very high lining and drum wear
- Squeal

SOLUTION Replace linings and avoid brake operation in dusty environment. Grind or replace drum as appropriate

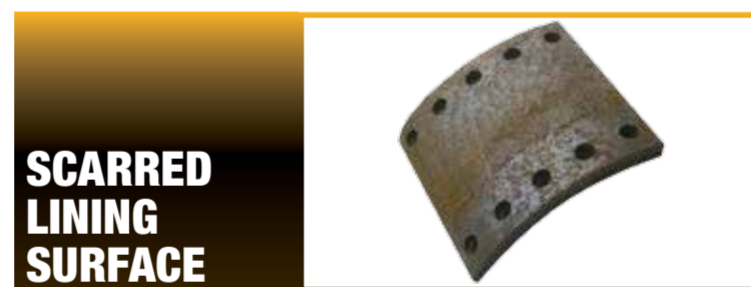
SCARRED LINING SURFACE

- Poor drum condition, e.g. heat crazing

- Rapid lining wear
- If linings not 100% bedded-in, low brake efficiency can result

SOLUTION Replace linings and avoid overheating brakes

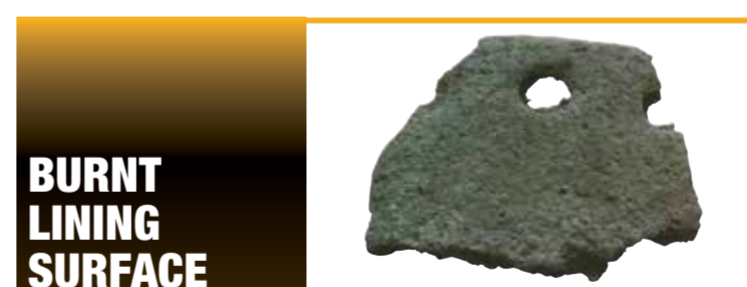
BURNT LINING SURFACE

- Faults in brake mechanism
- Sticking brake shoes (weak return springs)
- Excessive use of brakes from high speed
- Wrong brake cylinders/air chambers or levers
- Overloaded vehicle
- Incorrect brake proportioning between tractor/trailer units

- High lining wear
- Vehicle pull and excessive brake noise
- Deceleration too low

SOLUTION Replace linings, avoid overworking brakes and ensure brake components are correct and are in good condition

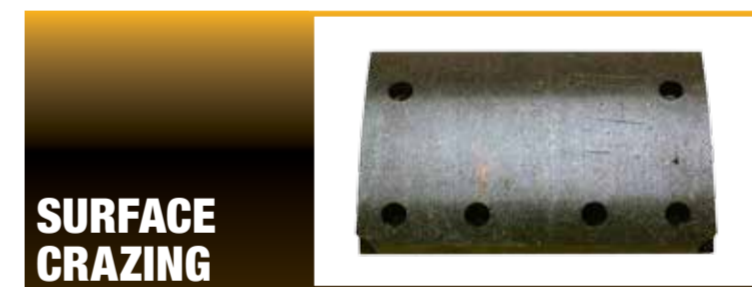
SURFACE CRAZING

- Caused by excessive brake temperature, i.e. when brake is cold on motorway then having to perform a sudden stop i.e. off a slip road. Rapid temperature input does not allow for heat soak from material into brake system

- This condition has no effect on the integrity or performance of the lining
- Penetration of the crazing is usually no more than 1mm deep
- Wear through with normal brake use and has no effect on the lining

SOLUTION Avoid high-speed heavy duty braking from cold

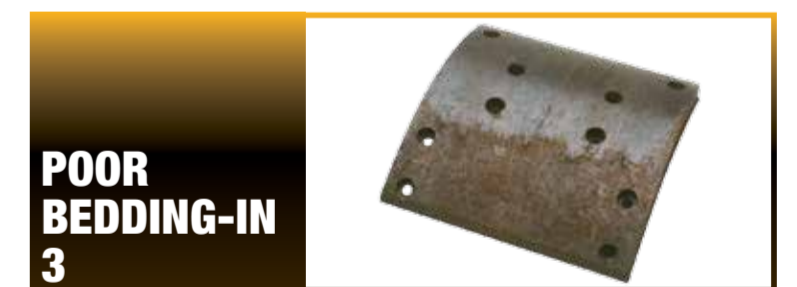
POOR BEDDING-IN 3

- Bedding-in period for the lining was too short
- Drum wear

- Either low or very high deceleration, with high deceleration the linings may lock on to the drum
- If the wear pattern differs across the axle, vehicle pull and excessive noise can result

SOLUTION Replace linings and ensure the correct lining radius to drum diameter is selected, or extend bedding-in period

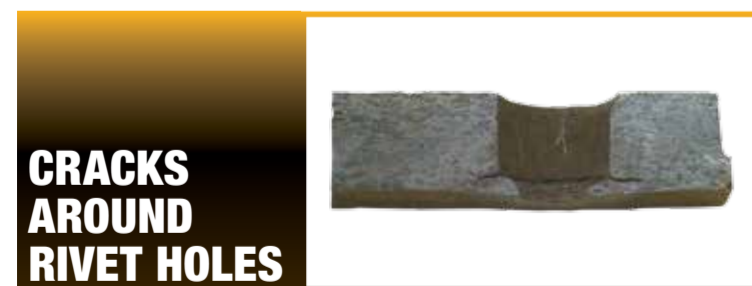
CRACKS AROUND RIVET HOLES

- Too heavy riveting force
- Wrong shape of rivet heads
- Brake shoe radius does not conform to lining radius
- Brake shoe platform is not clean or even

- Lining and drum breakage
- Brake over-heating
- Noise

SOLUTION Replace linings, and avoid excessive pressure during riveting operations

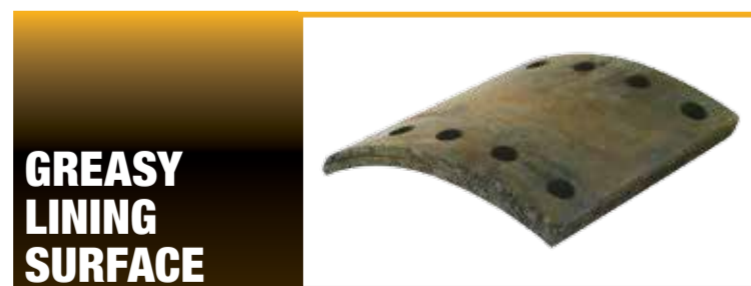
GREASY LINING SURFACE

- Broken or improperly mounted hub oil seals
- Excessive lubrication of the bearings of the braking mechanism

- Vehicle pull may occur if the problem is only found at one side of the axle
- Low deceleration

SOLUTION Remove grease from the linings, cure oil/grease leaks
